# **Field Report for Airborne Data Collected In Support of US EPA Region 6 Intercontinental Terminals Company LLC Fire 1 April 2019**

## **Data Results Flight 17, 1 April 2019**

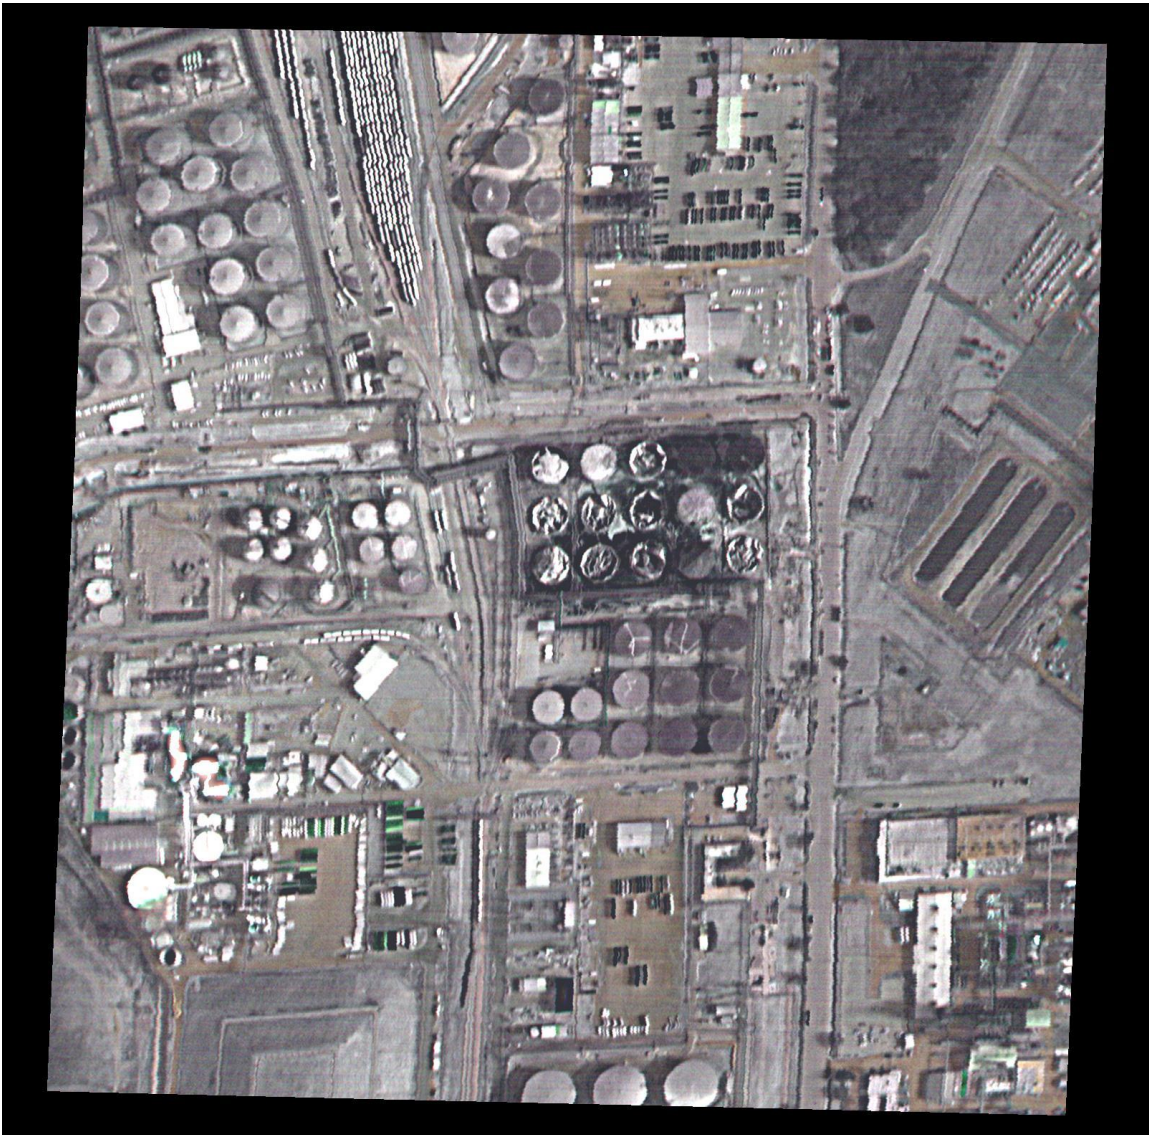
A total of 1 test and 6 data passes were made in the proximity of the impacted tank farm and also in extended areas surrounding the site and infrared line scanner images were generated for each pass. Figure 3 shows a typical 3-band infrared image obtained from data collected for Run 3. IR imagery of the tank farm indicates that all tanks are at ambient temperature other than IR solar heating. As with the flight on 31 March 2019 with tanks in the NE corner of the farm are the coolest.

Figure 3: IR image of ITC data for 1 April 2019, Flight 17 Run 5

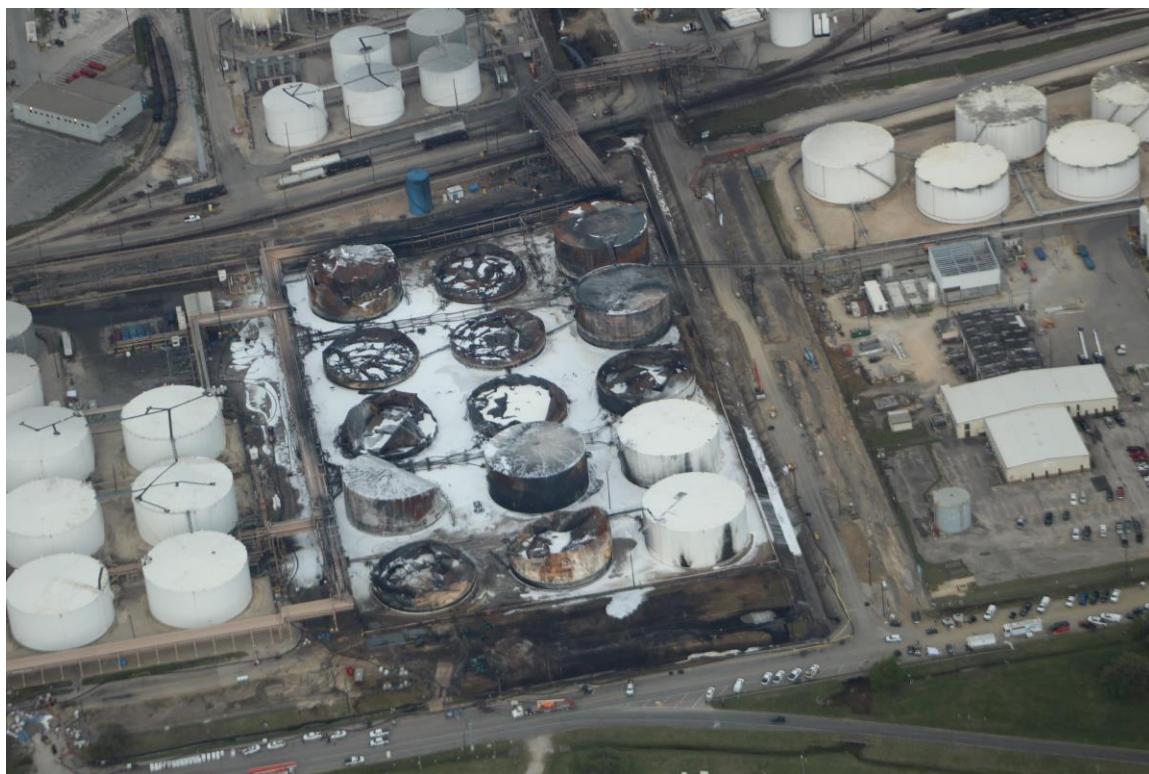
A full set of high resolution aerial digital photography was collected as part of the flight. Figure 5 shows a representative overhead image collected as part of each pass over the tank farm. Analysis of the image shows that several of the tanks appear to have the tops removed or collapsed. An oblique image of the tank farm confirms the status of the area (figure 6).

Figure 6: Oblique Image of the Tank Farm, 1 April 2019 Flight 17

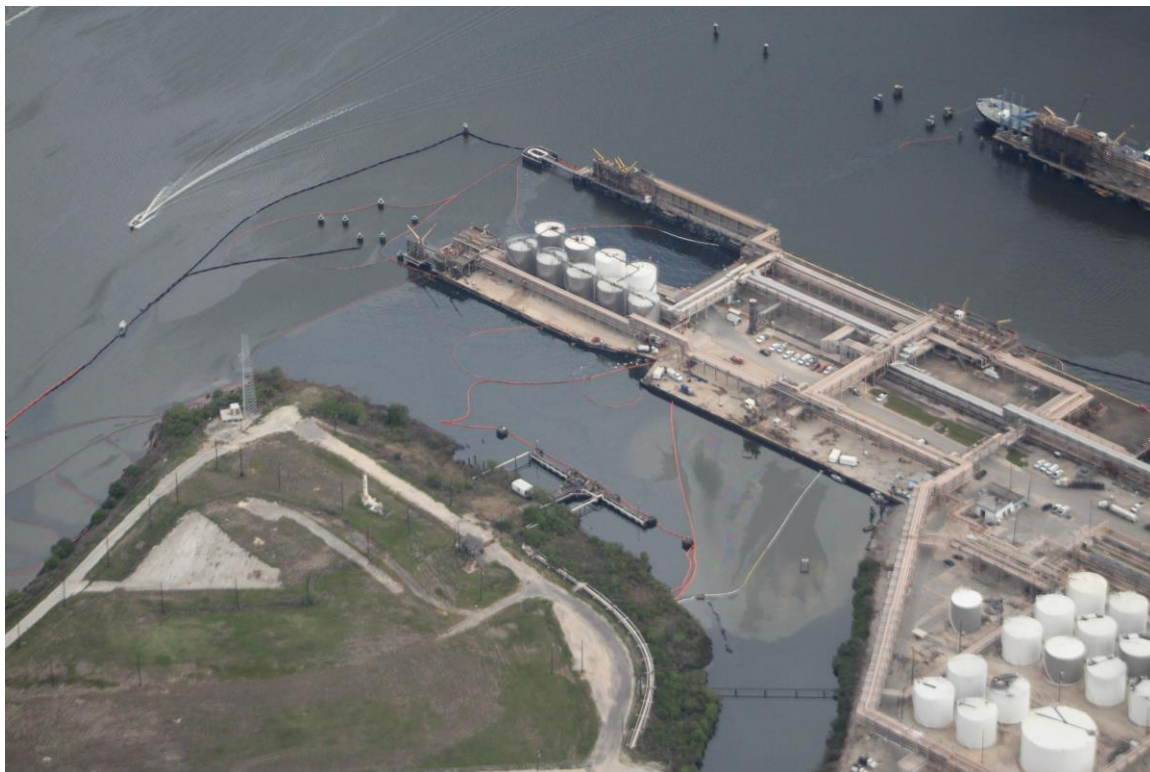
confirms the findings in the aerial view with sheen present in the lower booms and main channel (figure 8).

Figure 8: Oblique Image of the Ship Channel Boom Area, 1 April 2019, Flight 17
